2010.40.115)

Photo Album

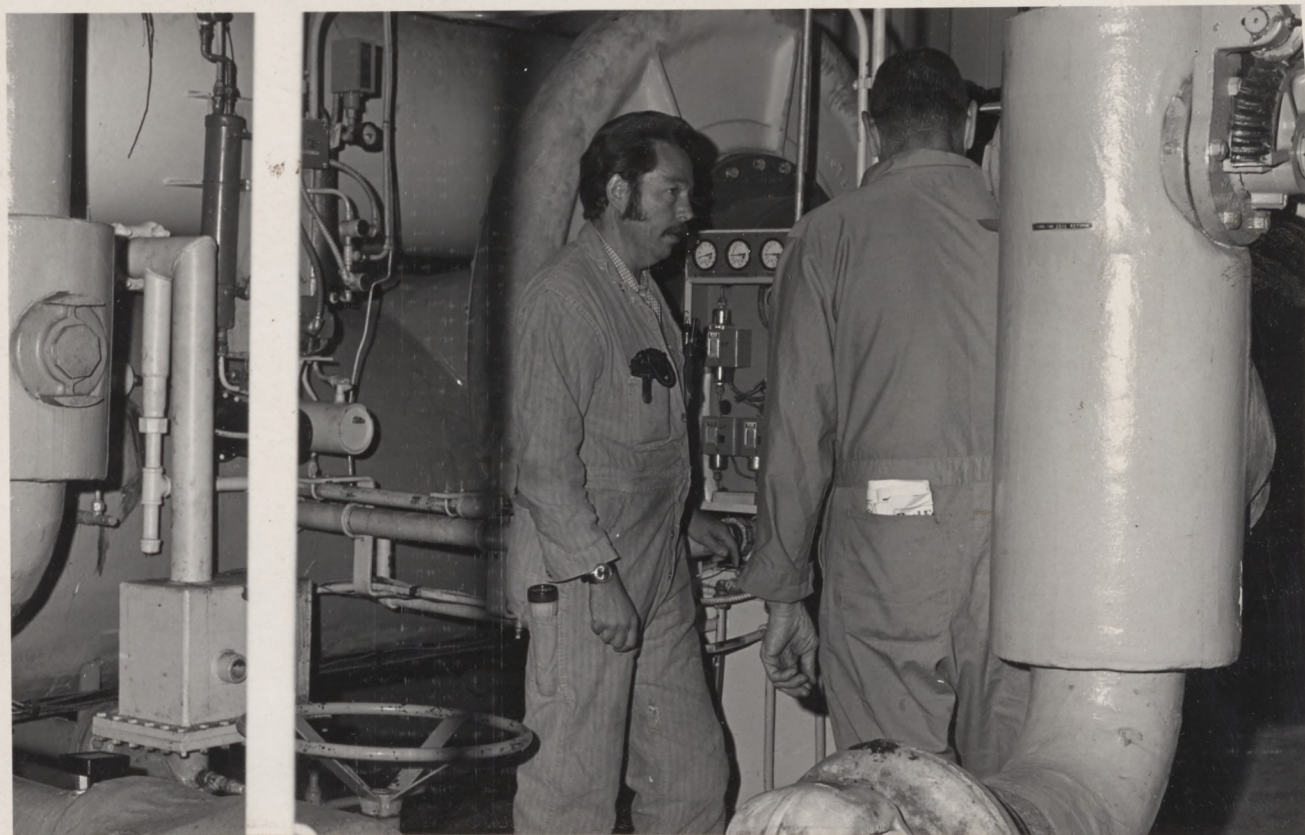
1979. Apprentice Air Conditioning & Refrigeration Terry Frey checks out the Main Buildings Air Conditioning Equipment with Journeyman Air Conditioning & Refrigeration Mechanic Don Ethier.

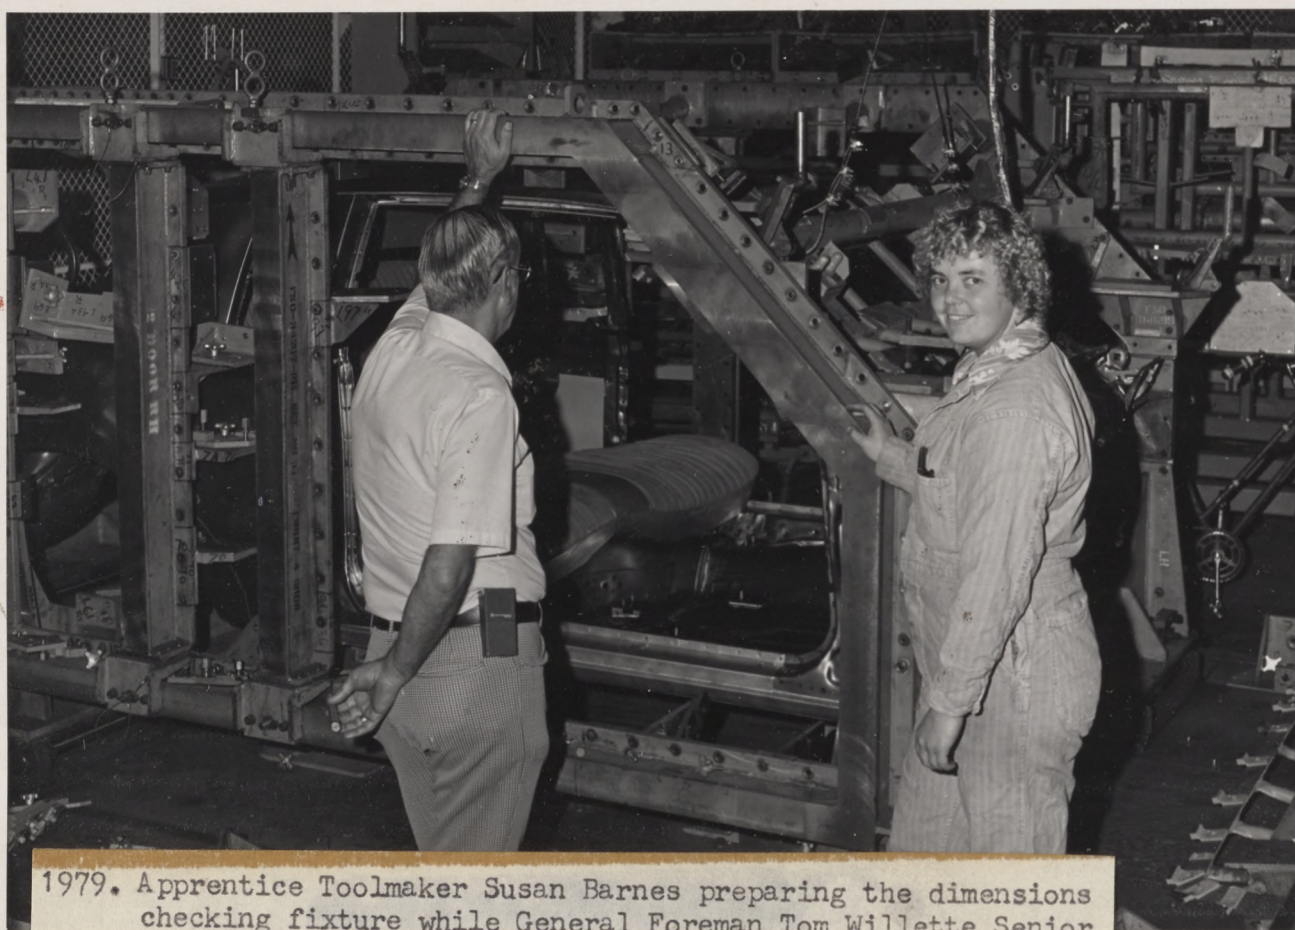
1979. Apprentice Toolmaker Susan Barnes preparing the dimensions checking fixture while General Foreman Tom Willette Senior Process Engineer looks on.

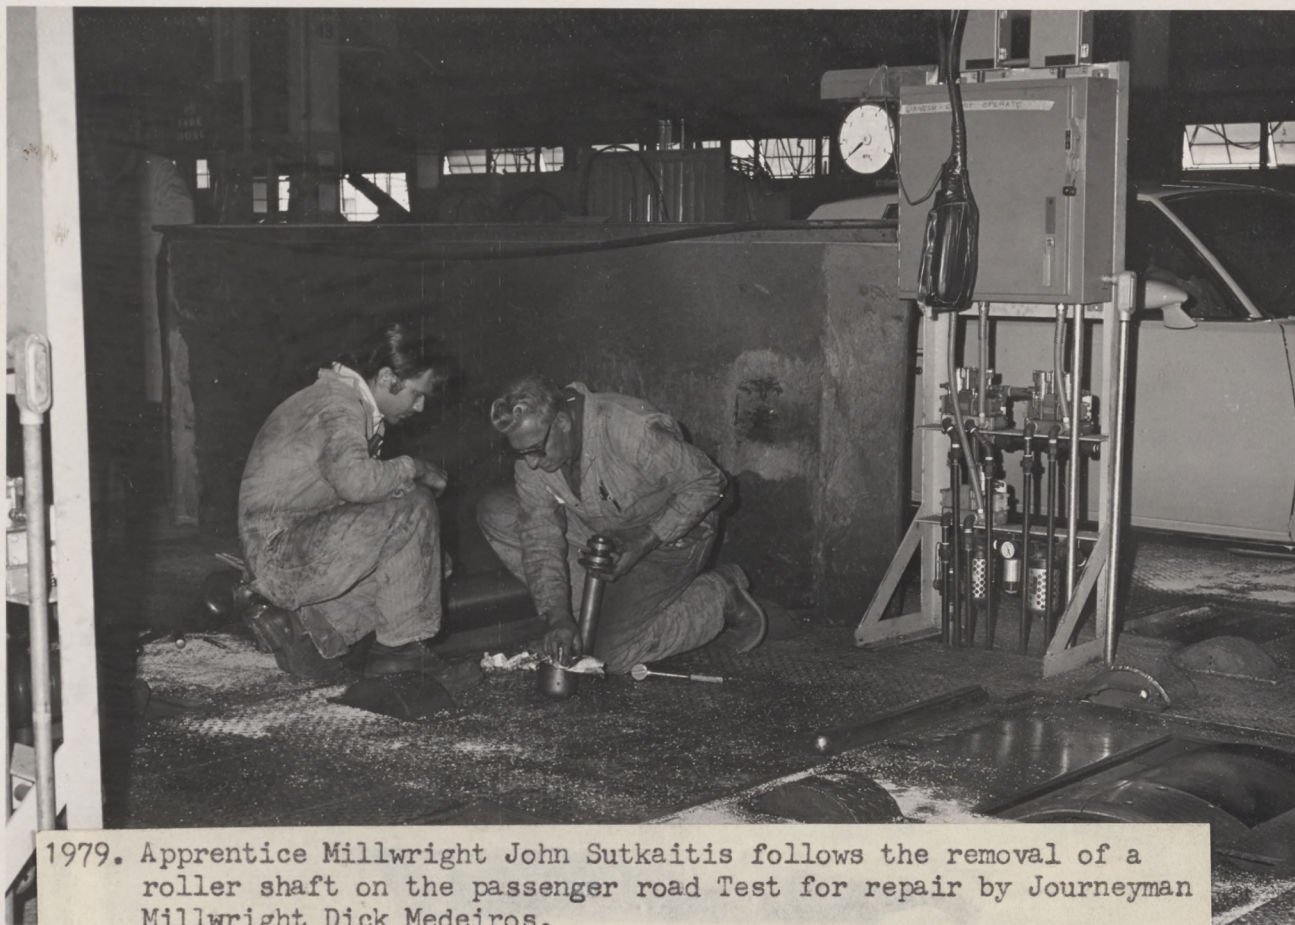
1979. Apprentice Millwright John Sutkaitis follows the removal of a roller shaft on the passenger road Test for repair by Journeyman Millwright Dick Medeiros.
